National Highway Traffic Safety Administration

Case Vehicle (A): 1999 Ford

Type: Ranger XL 4 x 4, 2-door pickup

Driver: 27-year-old male CDC: 12-FYEW-2

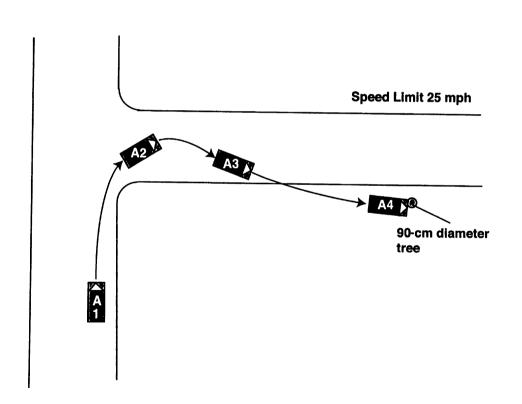
ACCIDENT DESCRIPTION: Che vehicle (a) was traveling weath and	CASE VEHICLE (A): 1999 FORD RANGER PU
made a right tunn outs a gravel road. The driven	OTHER VEHICLE (B):
lost control of case vehicle (A) and the vehicle exited	THIRD VEHICLE (C):
the nond And struck A tree with its left-front.	
	NORTH

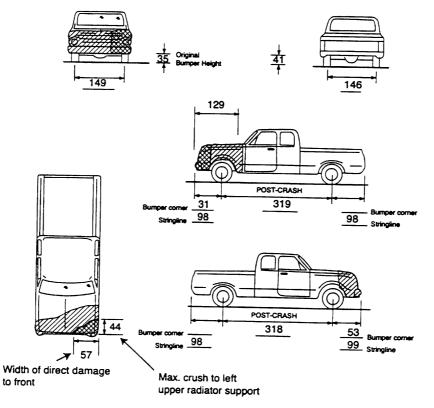
VEHICLE DAMAGE

(Slide 5) Damage to case vehicle (A) was moderate. (Slide 6) Direct damage began at the left bumper corner and extended 57 cm to the right, resulting in 40-percent vehicle overlap. (Slide 7) The maximum crush was 44 cm to the left upper radiator support.

Both front fenders, bumper and hood removed prior to inspection

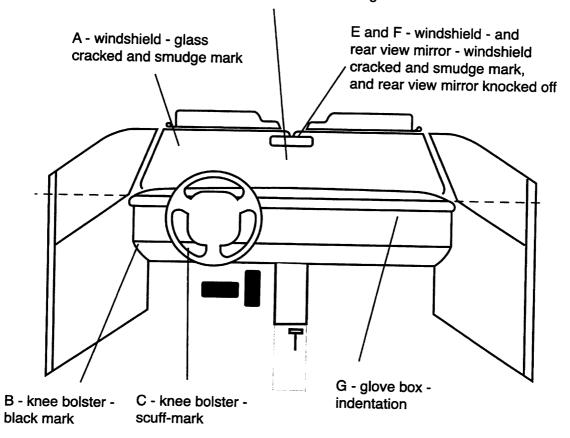
VEHICLE OCCUPANT CONTACT DIAGRAM

ļ					Confidence
	Interior	Occupant	Body		Level of
	Component	No. if	Region		Contact
Contact	Contacted	Known	if Known	Supporting Physical Evidence	Point
Α	Windshield	DR		Glass cracked and smudge mark	2
В	Knee bolster	DR	Lt. knee	Black mark	3
С	Knee bolster	DR	Rt. knee	Scuff-mark	1
D	Windshield	RF	Head	Glass cracked and smudge mark	1
E	Windshield	RF	Head	Glass cracked and smudge mark	1
F	Rearview mirror	RF	Head	knocked off mount	1
G	Glove box	RF	Rt. knee	indentation	1
Н					
I					
J					
K

D - windshield - glass cracked and smudge mark

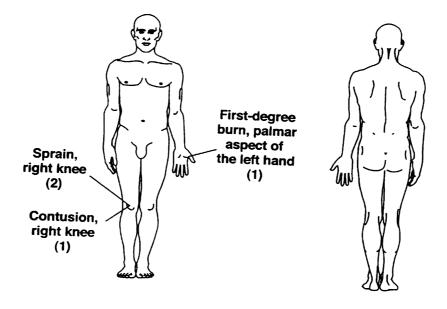
INDICATE LOCATION OF INJURIES.

Injury Source		
Injury Description	A.I.S.	Definite	Probable	Possible	
First degree burn, palmar aspect of the left hand	1		Airbag gas	2 000.010	
Sprain, right knee	2		Knee bolster		
Contusion, right knee	1		Knee bolster		
Maximum A.I.S. Level	2				
Injury Severity Score	5
